Technical Information

Concrete Pavement Engineering and Research

Rubblizing of Concrete Pavements: A Discussion of its Use

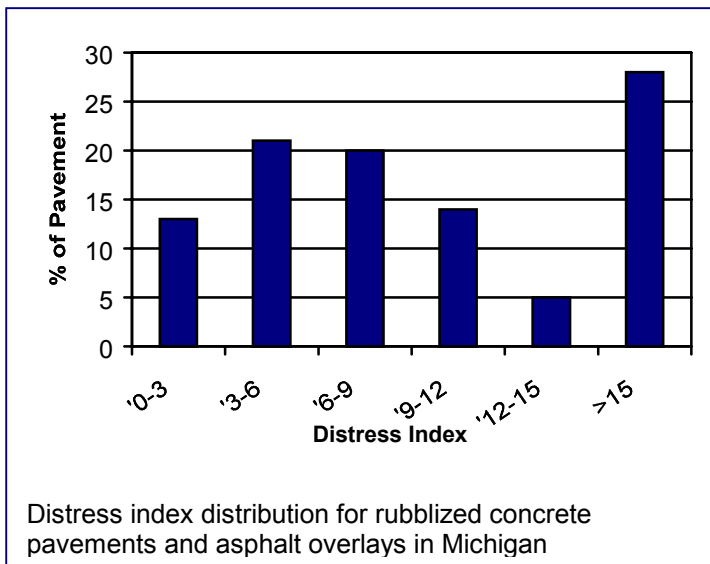
The state of Michigan has also had less than desired performance of their rubblized and asphalt overlaid pavements. The accompanying chart is from the Michigan Pavement Management System. It shows the 5-year distress index (DI) for 65.8 Km (40.9 miles) of rubblized and asphalt overlaid pavements. Note: a higher DI means poorer performance.³

The state requires that asphalt pavements with DI greater than eight be rehabilitated. Using this criteria, between 47-67% of the 5-year-old asphalt overlays on rubblized concrete pavements need

rehabilitation. For concrete pavements, the state requires that they be restored when the DI is greater than four. If that criterion were used, then between 67-87% of the rubblized projects would need rehabilitation. Finally, it is important to note that approximately 28% of all the 5-year-old rubblized overlay projects have a DI greater than 15, indicating substantial distress.

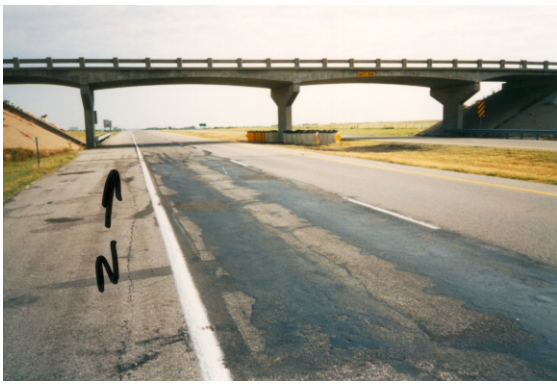
The project is in the southbound lanes of I-35 in Kay County, OK. The first photo shows a 100-mm (4-in.) asphalt overlay on a rubblized 228-mm (9-in.) jointed reinforced concrete pavement. The second photo shows an 8-inch asphalt overlay on the same pavement.

100-mm asphalt overlay on rubblized JRCP

A 1994 report⁵ stated that both these projects were controlling the reflective cracking. However, since that time, both have developed a considerable amount of longitudinal and fatigue cracking in the wheelpaths. Though the 200-mm (8-in.) overlay is outperforming the 100-mm (4-in.) overlay, it still has a considerable amount of distress considering it has only been in service for 6 years.

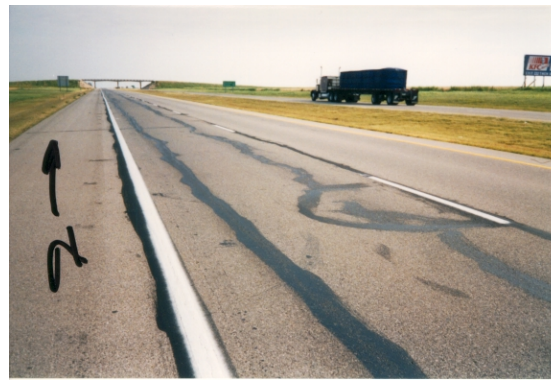
200-mm asphalt overlay on rubblized JRCP

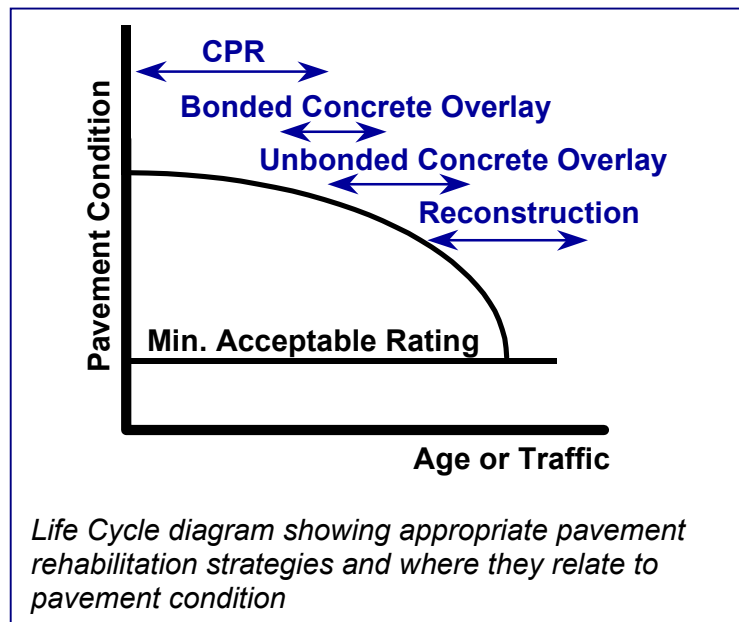
Table 1: Concrete Pavement Restoration Techniques

Concrete Pavement Restoration Technique	Used to:
Full-Depth Repairs	Repair cracked slabs and joint deterioration
Partial-Depth Repairs	Repair joint and crack deterioration and surface distress
Diamond Grinding	Extend serviceability; improve ride and skid resistance; reduce noise
Dowel-Bar Retrofit	Restore load transfer at joints and cracks
Joint and Crack Resealing	Minimize infiltration of water and incompressible material into joint system
Slab Stabilization	Fill small voids underneath the concrete slab
Cross-Stitching	Repair low and medium severity longitudinal cracks
Grooving	Reduce wet weather accidents and prevent hydroplaning
Retrofitting Edge Drains	Add a longitudinal drainage system
Retrofitting Concrete Shoulder	Decrease pavement edge stresses and corner deflections

Table 1 shows the CPR techniques. Each technique is specifically designed to repair or prevent the recurrence of a certain distress or a combination of distresses. While each technique can be used individually, they are more effective when several are used together. In some cases more than one CPR technique may be applicable. However, one technique is usually more suitable than the other because of the condition of the pavement.

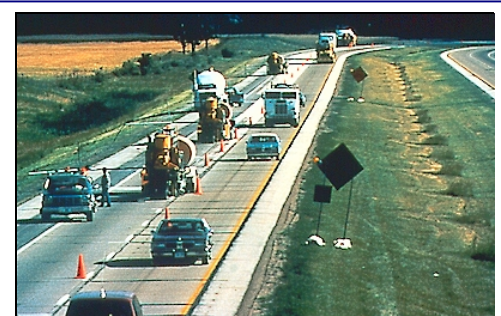
Diamond Grinding of an old concrete pavement to restore smoothness

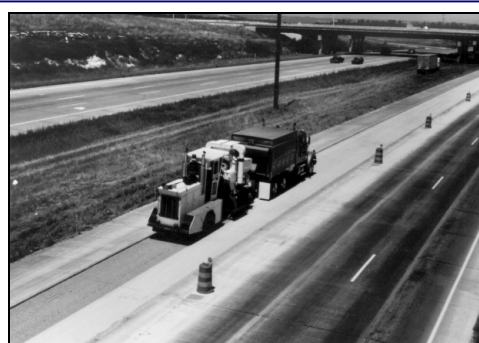
In order to ensure that bond develops, specific steps are taken to prepare the surface of the existing pavement. This is done with either shotblasting and milling. With shotblasting, steel shot are hurled at the pavement surface to remove about 3 mm (0.125 in.) from the pavement surface. This creates a rough and extremely porous surface that increases the mechanical interlock and provides a strong bond. Milling is primarily used where deeper removal is desired. It typically removes between 6 and 25 mm (0.25 and 1.0 in). Afterwards, a secondary cleaning is required, which is typically shotblasting.

Shotblasting the surface in preparation for a bonded concrete overlay.
